Staff Report

Report To:	Planning and Development Committee		
Date of Meeting:	February 1, 2021	Report Number:	PDS-007-21
Submitted By:	Faye Langmaid, Acting Director of Planning Services		
Reviewed By:	Andrew C. Allison, CAO	Resolution#:	PD-029-21, PD-113-21
File Number:	PLN15.2.2	By-law Number:	
Report Subject:	Cedar Crest Beach – Property Loss Study

- 1.7 The technical report prepared by Zuzek Inc., Port Darlington West Embayment Shoreline Change Assessment (January 25, 2021), is provided as Attachment 1.

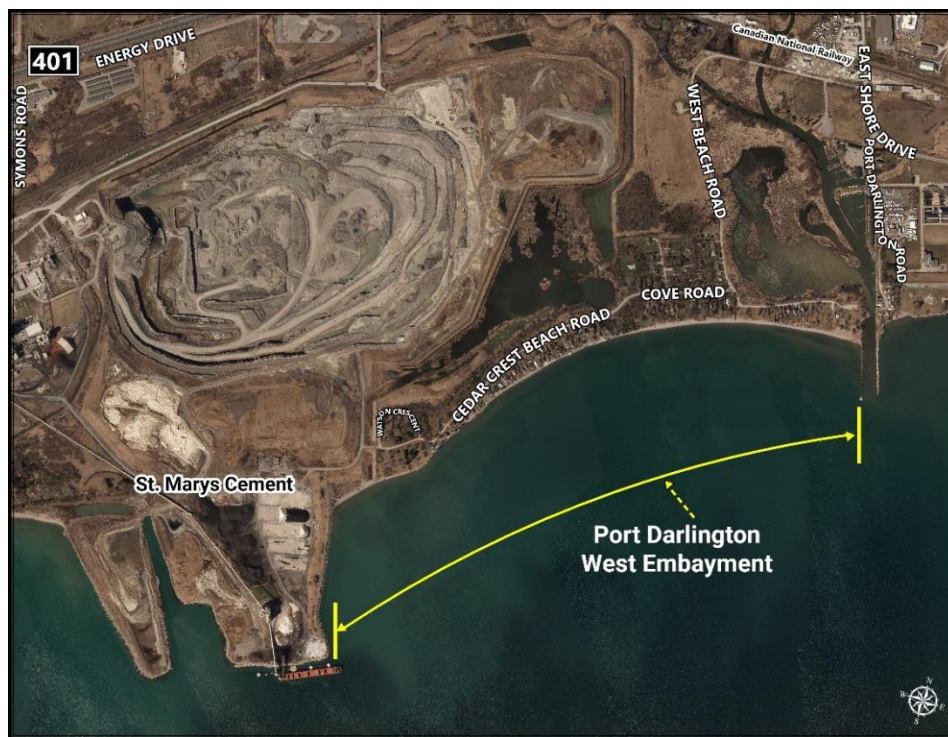
Figure 1: Key Map – Port Darlington West Embayment

- 1.1 The reach of Lake Ontario shoreline that is the subject of this report, referred to hereafter as the Port Darlington West Embayment, extends from St. Marys Cement eastward to the piers at the mouth of Bowmanville / Soper Creek (approximately 1,800 m). The area is subject to multiple natural hazards, including lake flooding, erosion and dynamic beach, and riverine flooding from the adjacent Westside Creek and Bowmanville / Soper Creek watersheds and marsh systems. The Port Darlington West Embayment is shown in Figure 1.

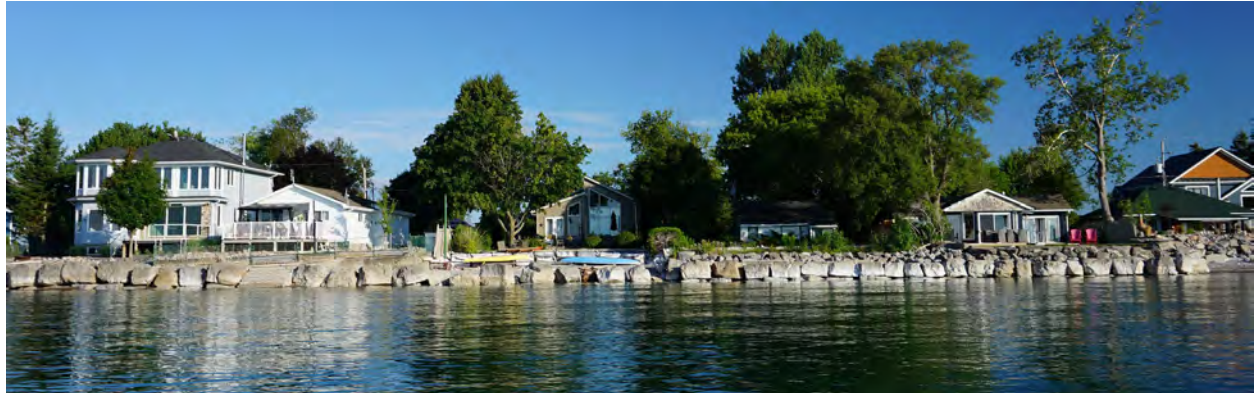
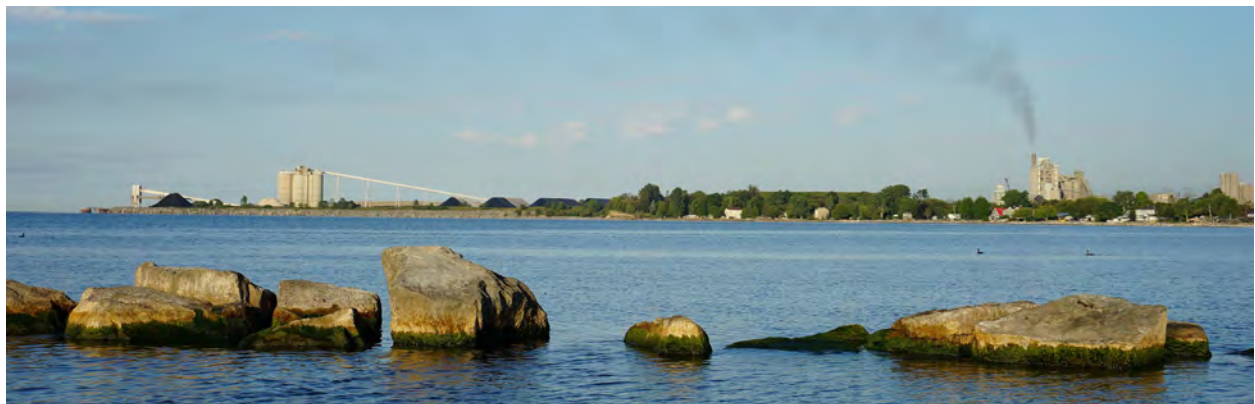
View of Cedar Crest Beach Shoreline (top) and St. Marys Cement Headland (bottom) from the Port Darlington Navigation Channel on August 7, 2020

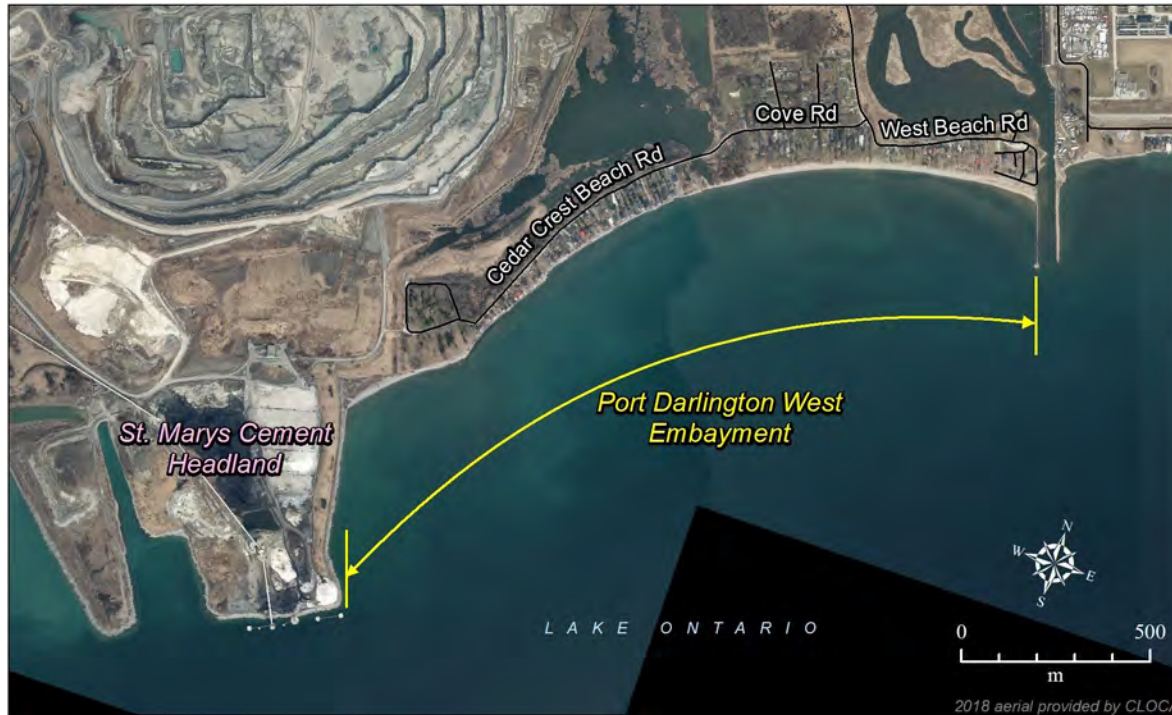
Figure 1.1 Port Darlington West Embayment

Cedar Crest Beach is located on the north shore of Lake Ontario immediately west of Port Darlington and east of the St. Marys Cement (SMC) facility in the Municipality of Clarington. Refer to Figure 1.1. The Port Darlington navigation channel has been stabilized with jetties since at least 1860, a period of 160 years. Lake filling to create the main SMC Headland occurred between 1974 and 1979, with the western portion constructed in the late 1990s. This report summarizes the shoreline change assessment for the Port Darlington West Embayment completed by Zuzek Inc. and SJL Engineering Inc.

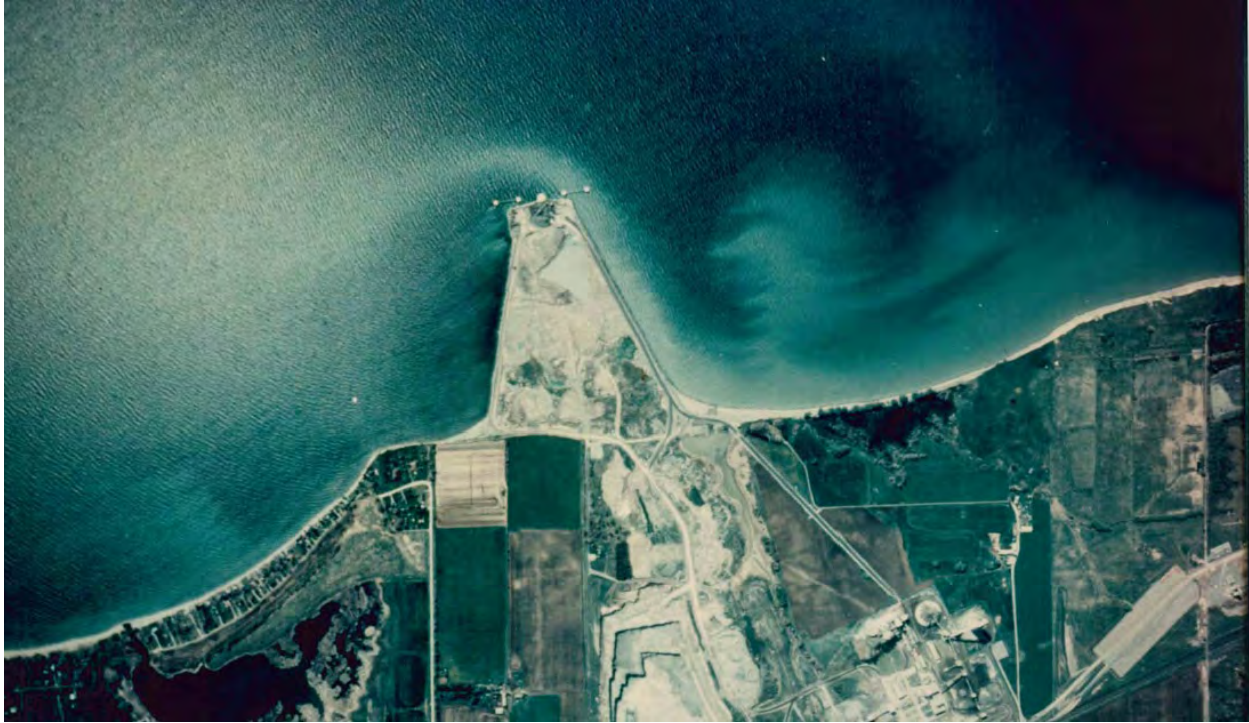
Figure 1.2 Original SMC East Headland (image courtesy of SMC)

Operation of the SMC plant in Bowmanville began in 1967/68, with the lake filling for the main eastern pier occurring from 1974 to 1979. Prior to the construction of the SMC Headland, the shoreline consisted of an eroding bluff and small embayment protected by a barrier beach. The newer western portion of the headland was constructed in the late 1990s (Municipality of Clarington, 2017). An aerial picture of the original eastern headland following construction is provided in Figure 1.2. The influence of the SMC Headland on sediment bypassing will be investigated in the study, along with Port Darlington jetties.

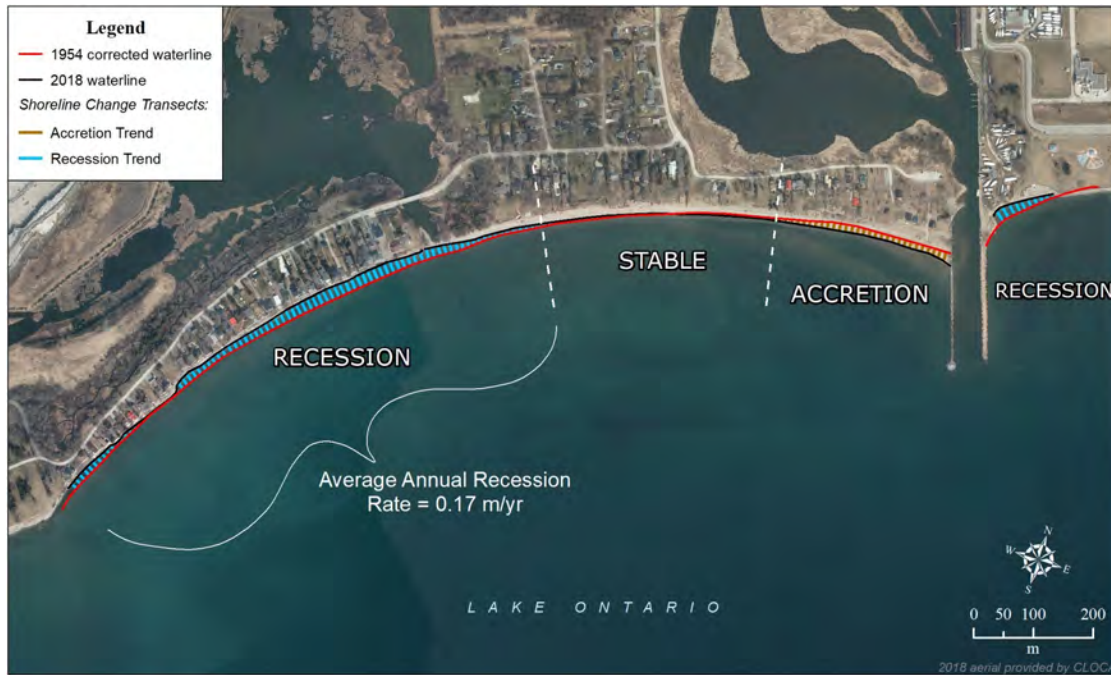
Figure 2.3 1954 to 2018 Waterline Comparison

Adjacent to the west jetty at Port Darlington, the shoreline has been migrating slowly lakeward, noted as a zone of accretion in Figure 2.3. The central portion of the Port Darlington West Embayment has been stable from 1954 to 2018 (no significant recession or accretion trend). The

shoreline for the western portion of the embayment has been receding from 1954 to 2018, with an average long-term recession rate of 0.17 m/yr.

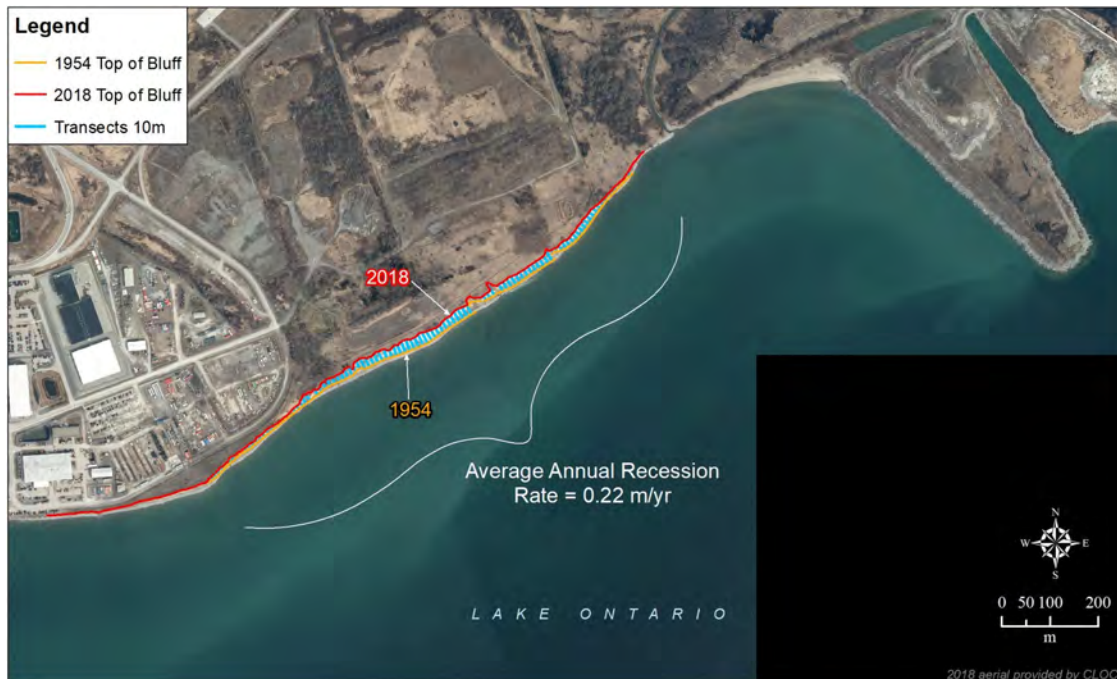
Figure 2.4 Bluff Recession West of SMC Headland

Between the Darlington Nuclear Generating Station and the SMC Headland, changes in the position of the glacial till bluff crest were also measured. The bluff has been eroding at an average annual recession rate of 0.22 m/year from 1954 to 2018. Refer to Figure 2.4.

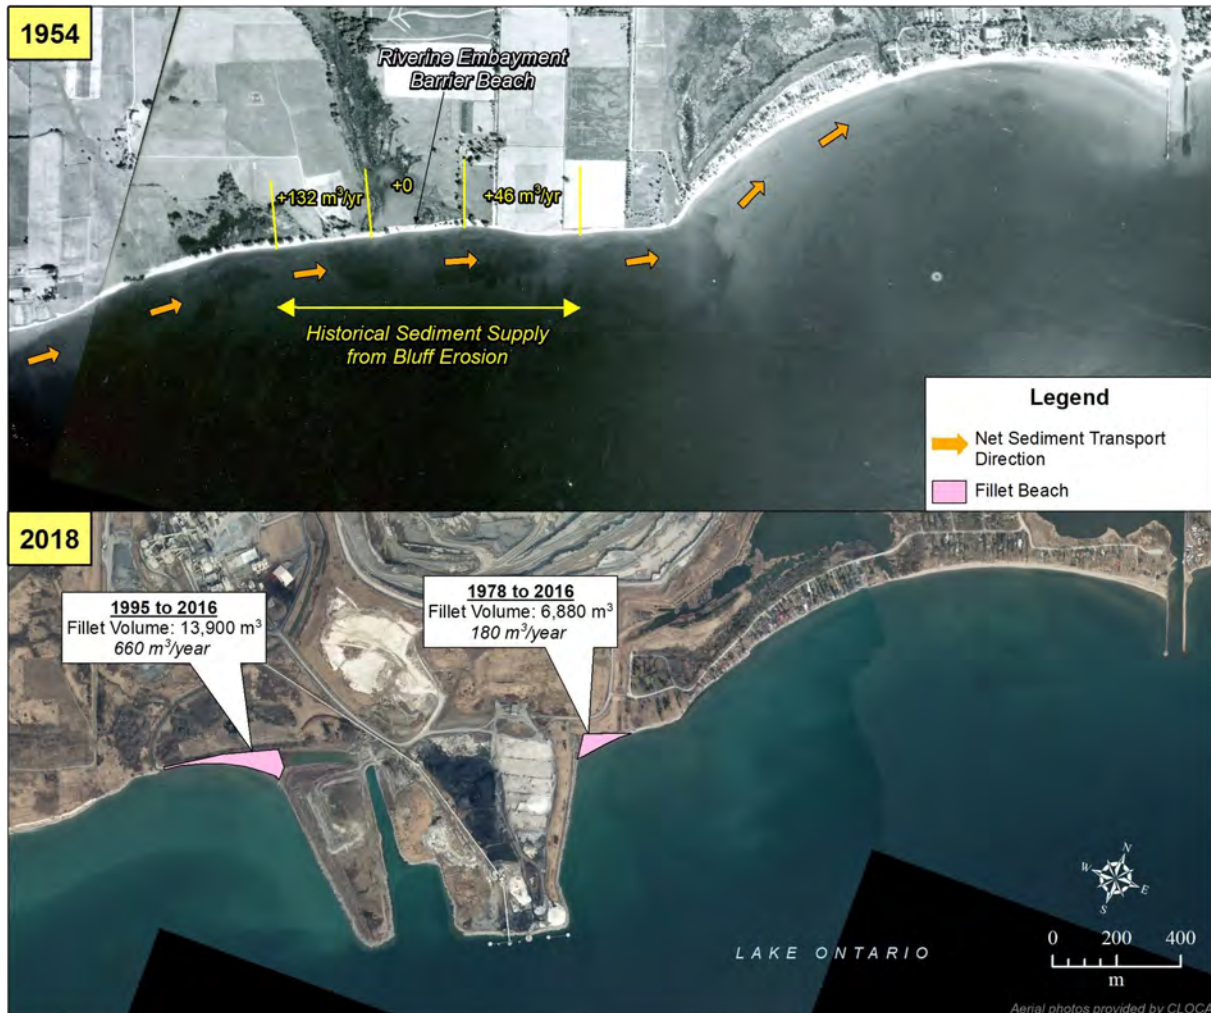
Figure 2.5 Pre-lakefill Shoreline Recession and Current Fillet Beaches

Prior to the construction of the SMC Headland, the bluff shoreline corresponding to the footprint of the headland was receding and contributed approximately 178 m³/year of sand and gravel to the shoreline. Refer to Figure 2.5 (top panel). With a net sediment transport direction of west to east (Zuzek Inc., 2020), this material would have historically been transported eastward into the Port Darlington West Embayment.

The spatial extent of the east and west fillet beaches associated with the existing SMC Headland are mapped in the bottom panel of Figure 2.5. From the late 1990s to 2016, the west fillet beach has trapped approximately 14,000 m³ of sand and gravel, or 660 m³/yr. From the late 1970s to 2016, the smaller east fillet beach has trapped roughly 7,000 m³ of sediment or 180 m³/yr.

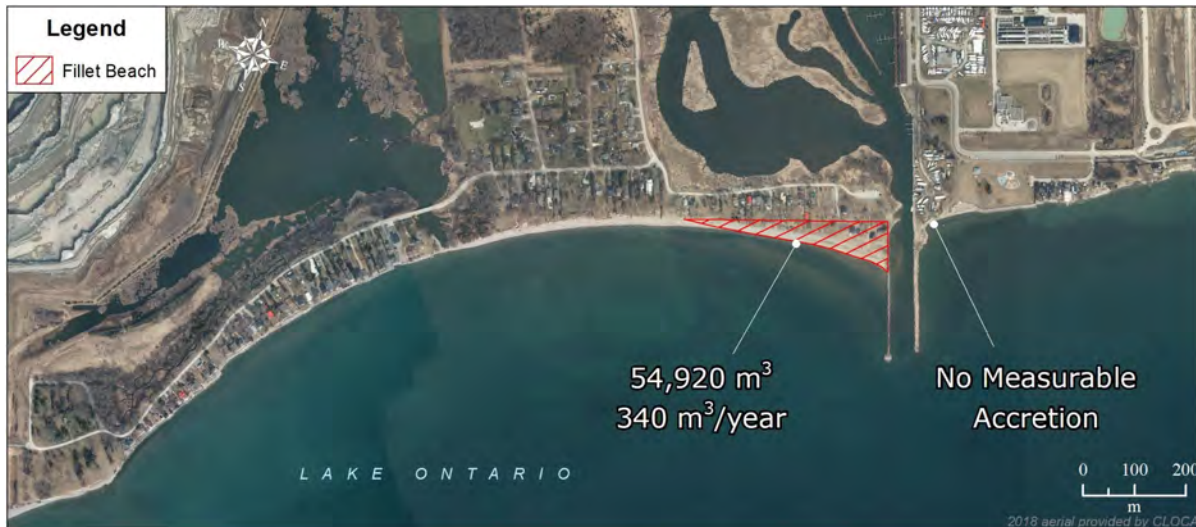
Figure 2.6 Port Darlington Fillet Beach Volume Estimates

As noted in Section 2.1, the Port Darlington jetties have been in place since at least the mid-1800s, with the Harbour Company being established in 1837. The west jetty has been trapping sand and gravel that was moving west to east along the shoreline for at least 160 years. As seen in Figure 2.6, the volume estimate for the west fillet beach is approximately 55,000 m³, which translates into an annual accretion rate of 340 m³/year. This is likely an underestimation of the total volume of eastward transport, as additional sand and gravel have accumulated in the navigation channel. This additional volume was not estimated, and historical dredging records were not investigated.

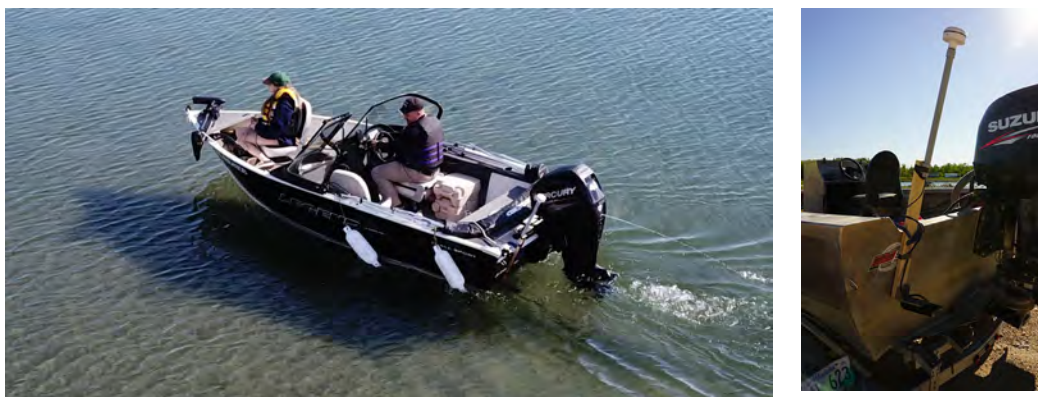
Figure 3.1 Survey Boat (left) and Transducer Mount (right)

A detailed bathymetric survey of the nearshore zone in the Port Darlington West Embayment was completed on August 7, 2020. Figure 3.1 provides a picture of the survey boat (left) and SOLIX transducer mounted on the back of the boat (right). The SOLIX is a single-beam bathymetric system for recording lake bottom depths and sonar images of the bottom substrate. The survey track used to navigate the boat is presented in Figure 3.2 and the resulting colour-coded depth data collected with the SOLIX is plotted in Figure 3.3.

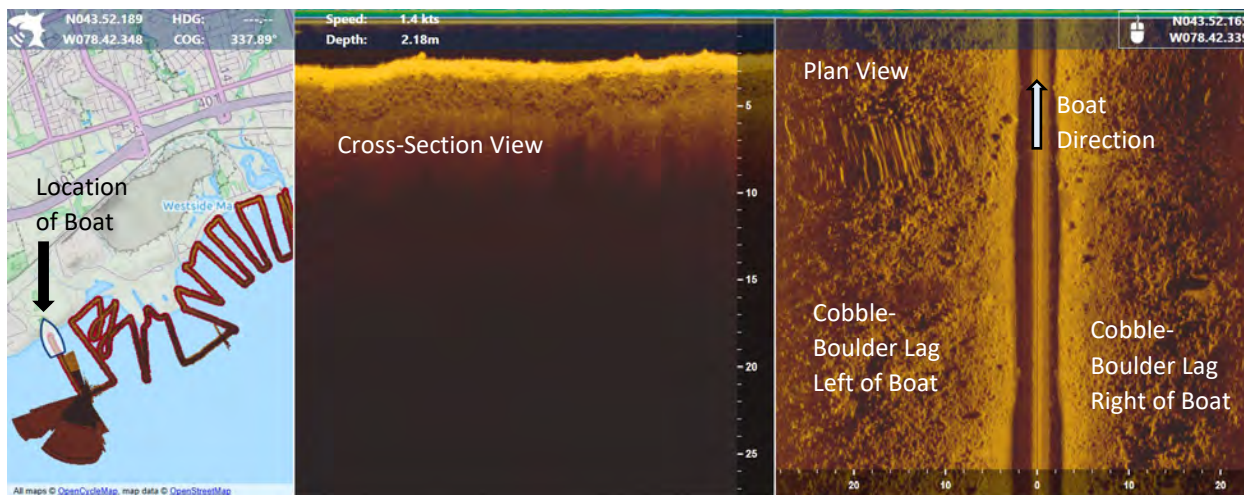
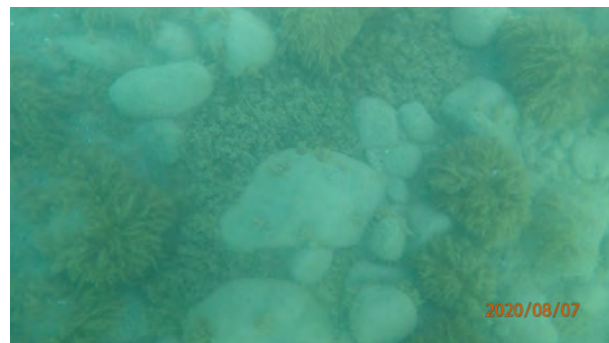
Figure 3.4 Profile 1 (top), Sonar Imagery (middle), Underwater Pictures of Cobble Lag (bottom)

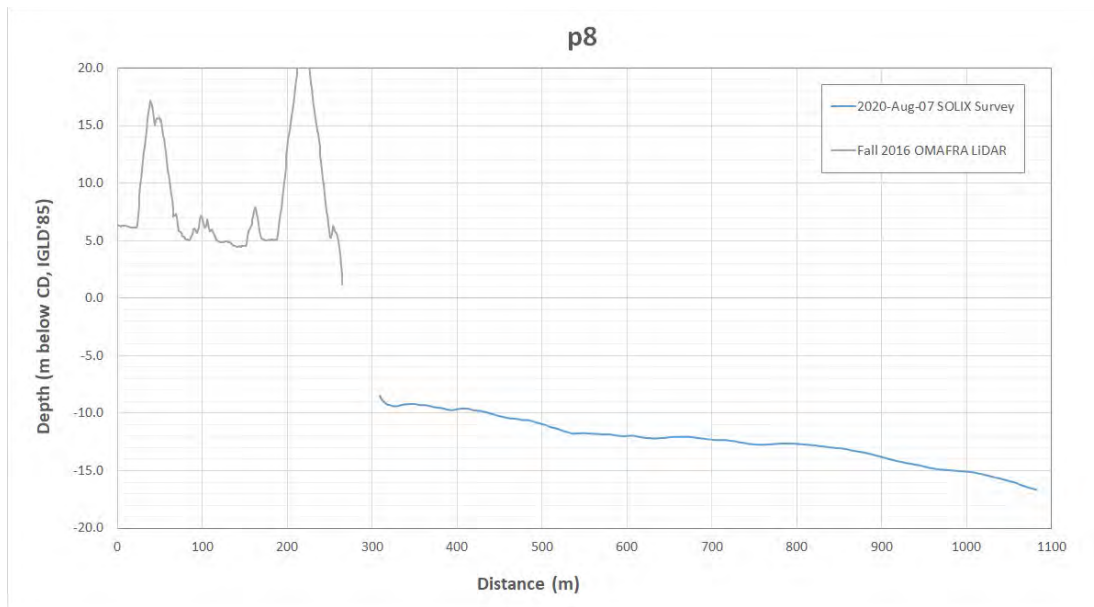
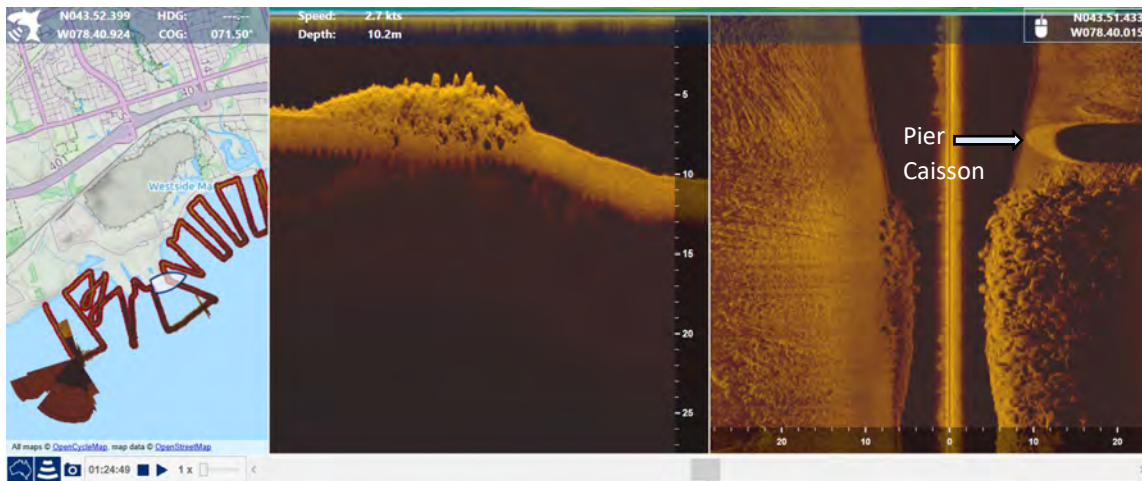
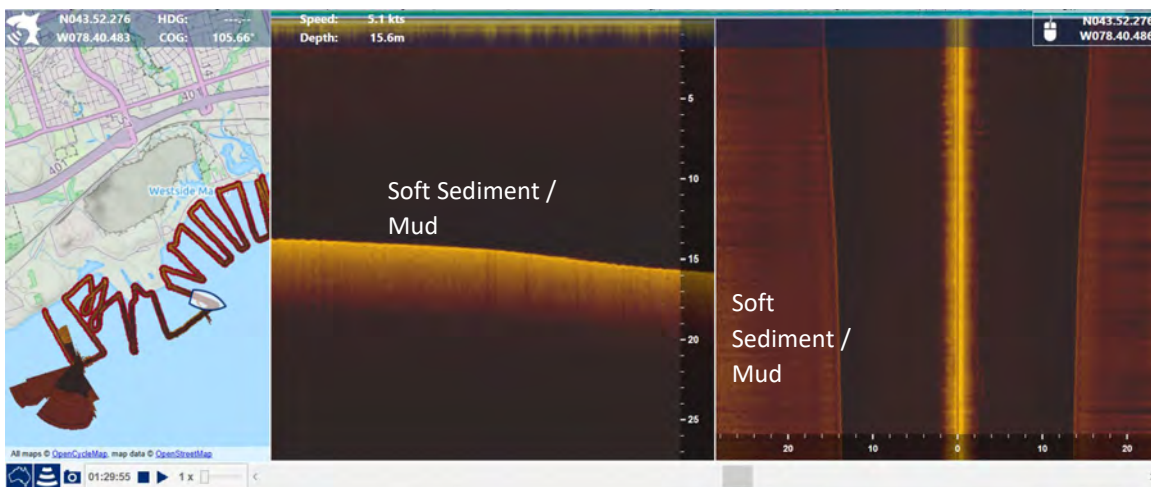
Figure 3.6 Profile 8 (top), Sonar of Wharf Armour Stone and Concrete Caisson (middle), Mud Lake Bottom (bottom)

- **Profile 8 SE Tip of SMC Headland:** Profile 8 records the conditions at the southeast corner of the SMC Headland. Like Profile 6, the lake bottom is very deep at the pier (~10 m) and progresses quickly to a depth of 15 m. There is no evidence of a sand lake bottom, sandy bypassing shoal or bar system that could facilitate the movement of sediment around the headland. In contrast, the sonar imagery suggests the lake bottom features soft/muddy sediment.

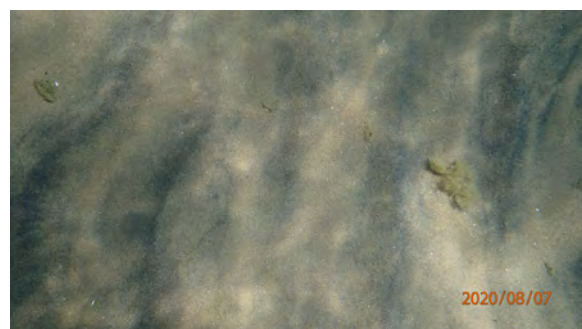
Figure 3.7 Profile 13 (top), Sonar Imagery of Transition from Cobbles and Sand Substrate (middle), Underwater Picture of Cobble Lag (bottom left) and Sand Substrate (bottom right)

- **Profile 14 Cove Road:** Profile 14 in Figure 3.8 is typical of the beach and nearshore conditions along Cove Road. The homes are set back further from the waters edge and a wide beach transitions to a shallow gently sloping nearshore. The slope at the waters edge (approximately 150 m on the x-axis) is much gentler than Profile 13 (175 m on the x-axis of Figure 3.7, top panel) which is typical of the nearshore along Cedar Crest Beach.

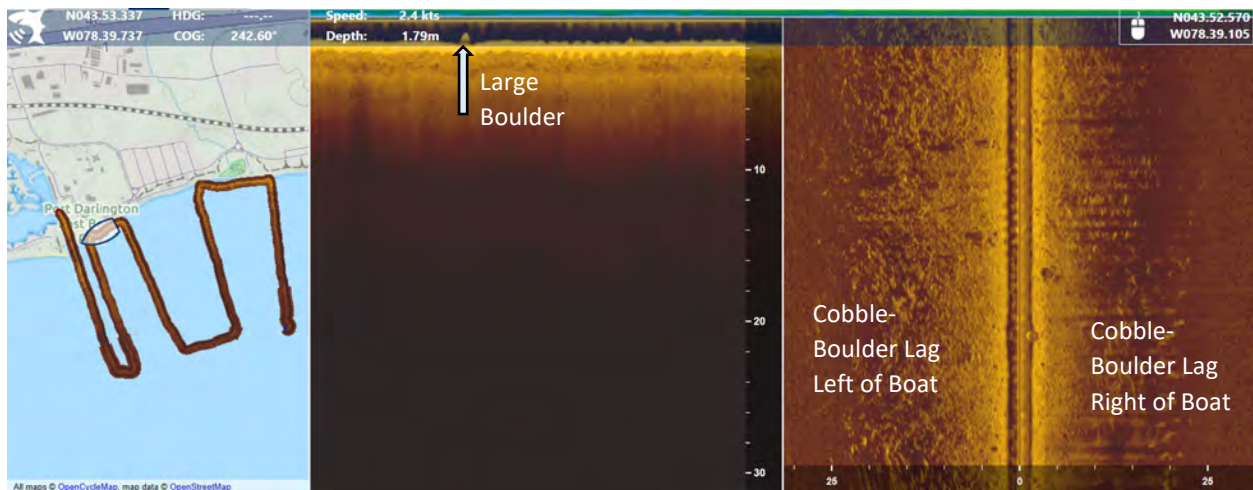
Figure 3.10 Cobble-Boulder Lag Deposit in Nearshore between Line 19 and 20

- **Profile 20 Eroding Bluffs East of Port Darlington:** Profile 20 is typical of the shoreline and nearshore conditions east of Port Darlington (Figure 3.9). Steep eroding bluffs define the shoreline, and the nearshore profile is flat, featuring a slope similar to Profile 1 (1:100) between the waters edge and the 4 m depth contour. The sonar mapped an extensive cobble-boulder lag deposit between Lines 19 and 20. Refer to Figure 3.10. No significant sand deposits were identified with the mapping.

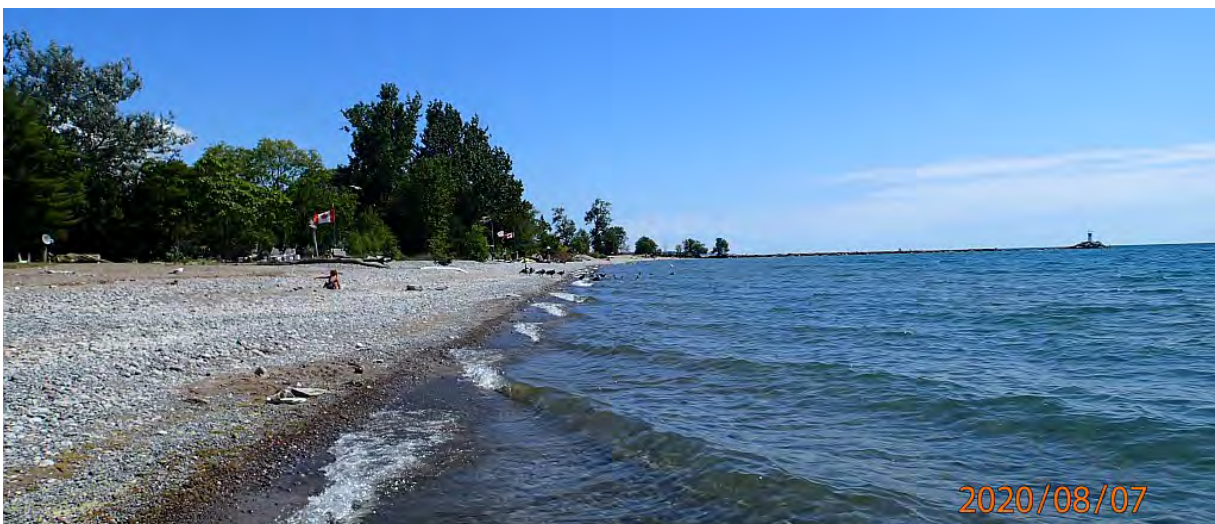
Figure 3.11 Alongshore View of West Beach

At West Beach, a mixed sand-cobble beach transitions to a narrow sandy nearshore, followed by an extensive cobble-lag deposit. Refer to Figure 3.11. There are no major sand deposits in the study area other than the fillet beaches and the largest sand deposit (West Beach) only exists because of the artificial littoral barrier formed with the construction of the Port Darlington jetties 160 years ago. Immediately offshore of the SMC Headland and in depths greater than 10 m, the lake bottom consists of soft sediments (mud).
