Staff Report

Date of Meeting: April 27, 2020 **Report Number:** EGD-006-20

Report Subject: Cedar Crest Beach Rd and West Beach Rd Berm Review and Estimates

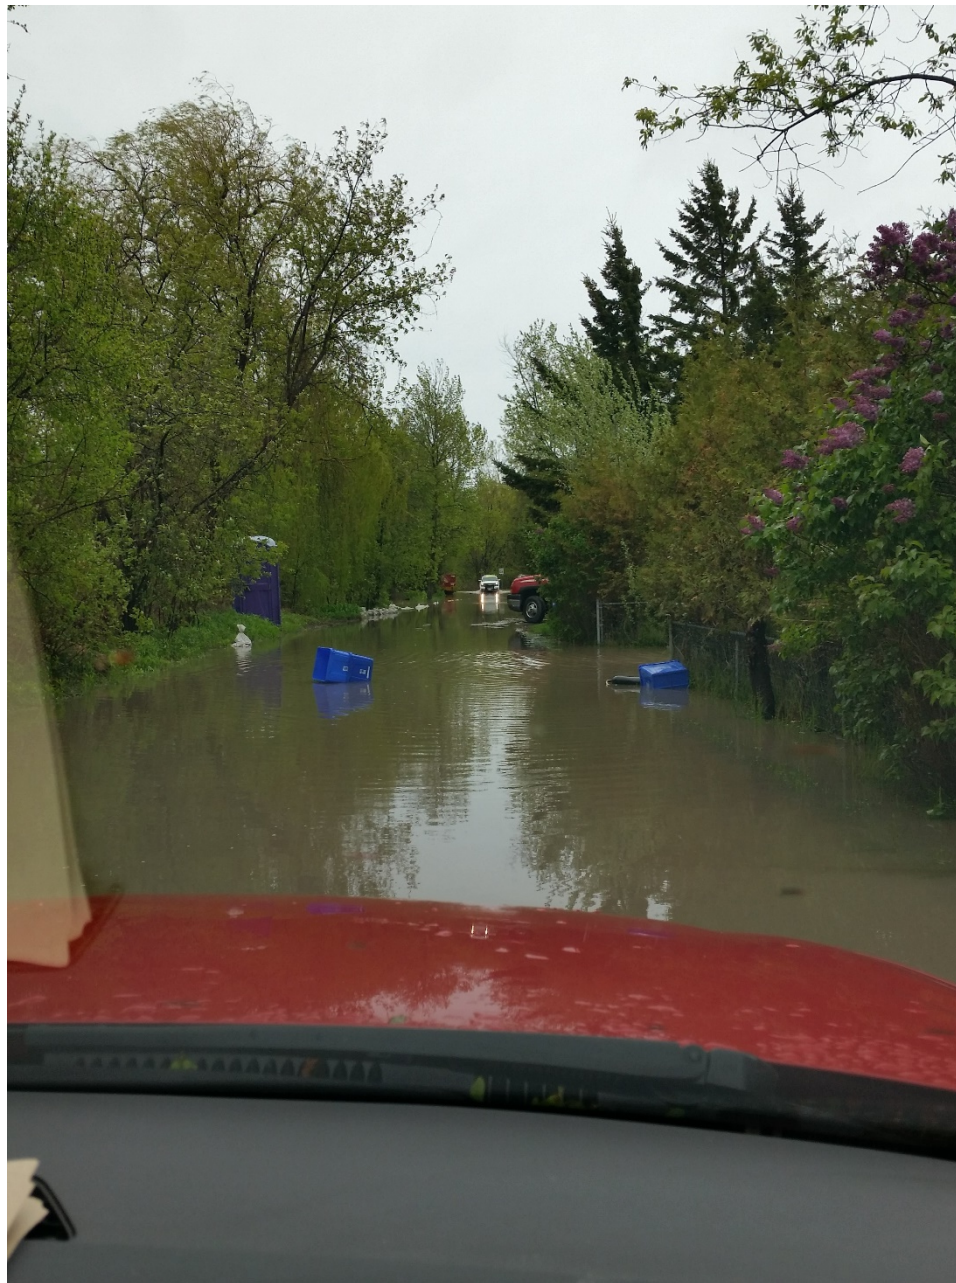
permanent berm solution to avoid having to deploy resources to create a barrier with sand bagging along this edge as has been done in the past. Figures 1-3 show past flooding of Cedar Crest Beach Road.

Figure 1: Cedar Crest Beach Road Flooding

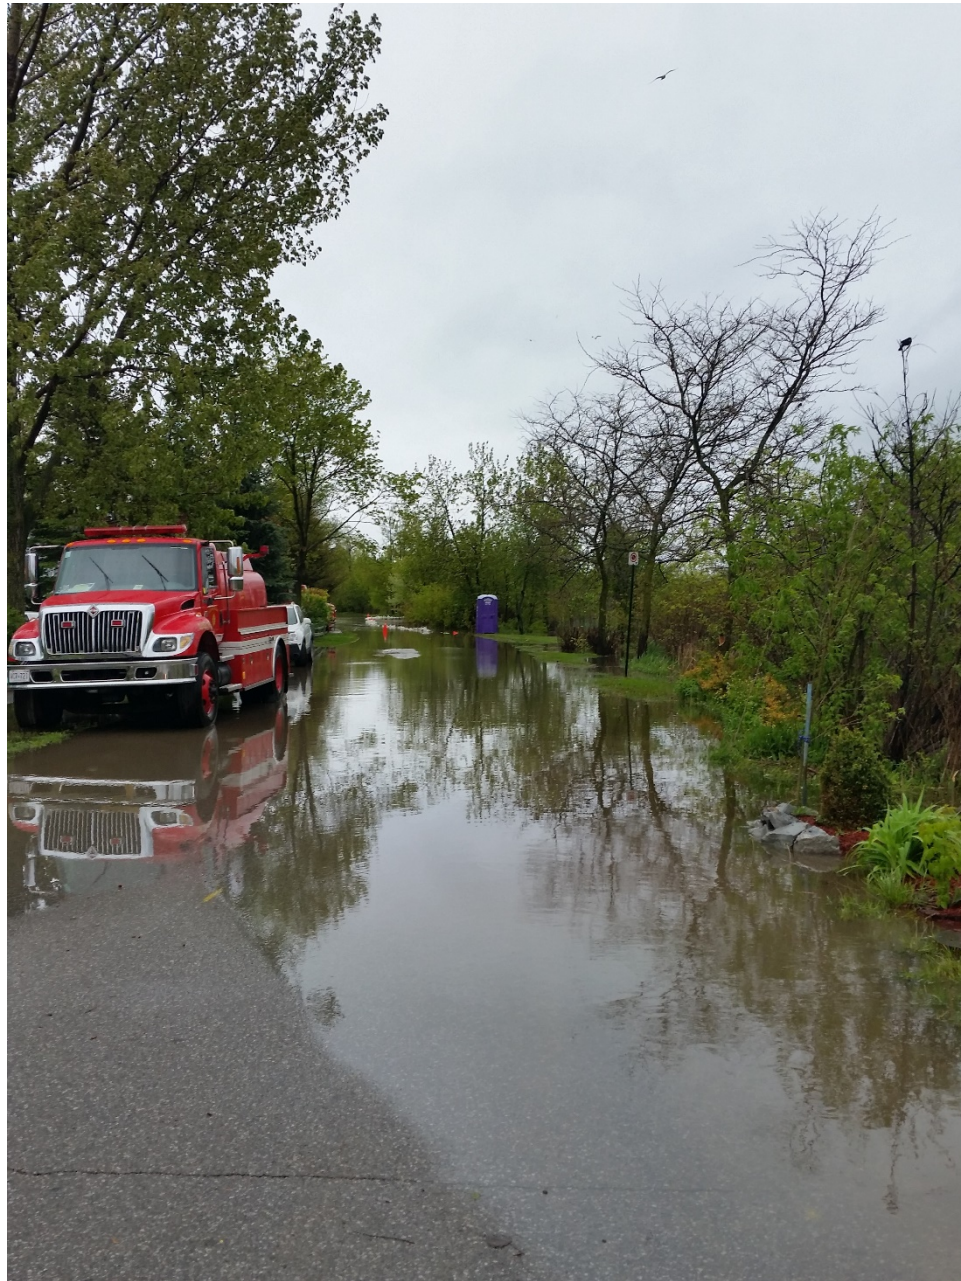
Figure 2: Cedar Crest Beach Road Flooding

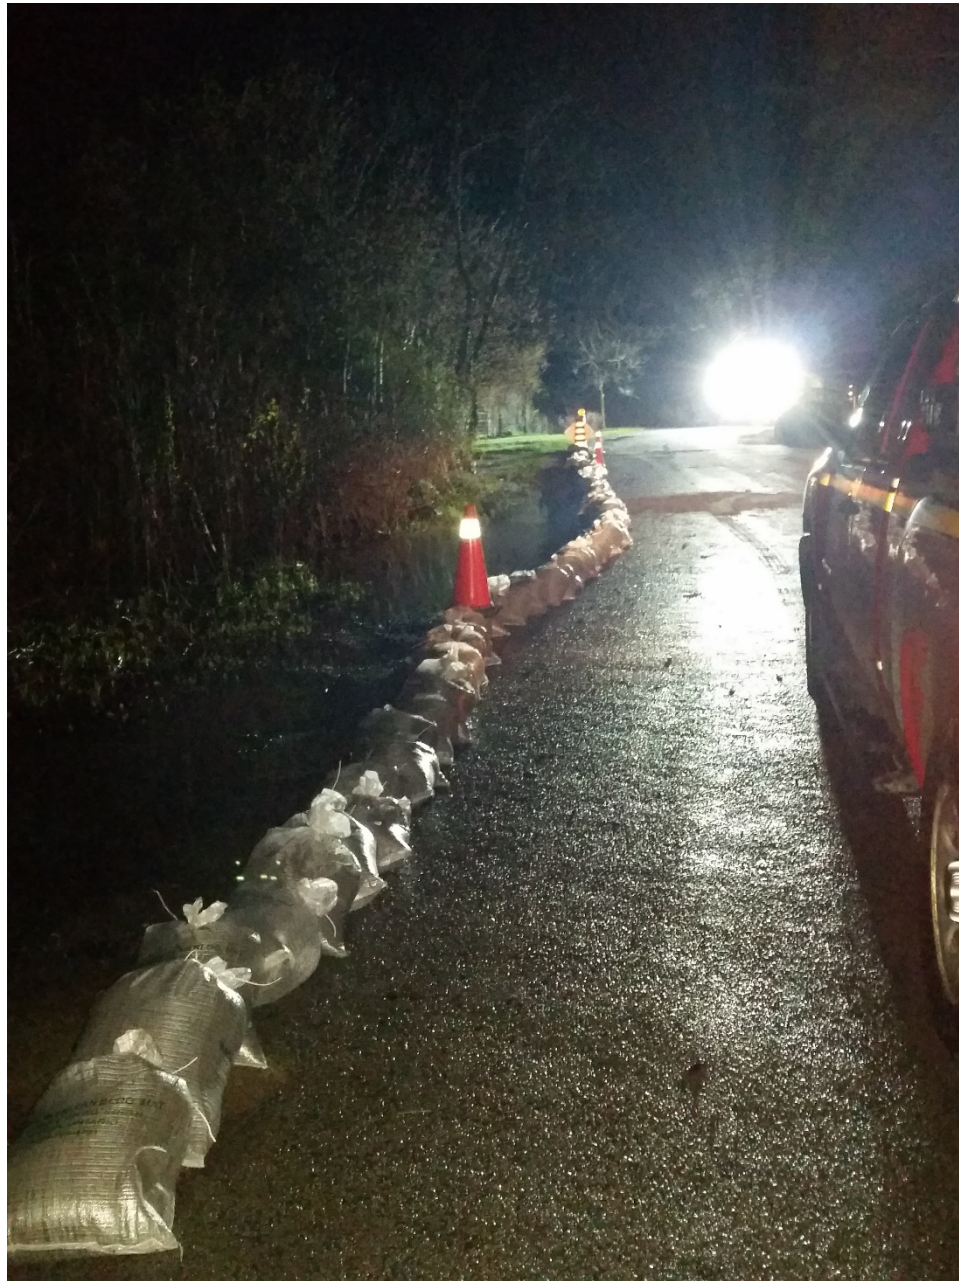
Figure 3: Sandbag Berm on Cedar Crest Beach Road

- 1.7 In reviewing the flood data from the 2017 and 2019 highwater events, it was found that 75.85 m was the flood elevation that compromised Cedar Crest Beach Road. During these events, attempts were made to protect the road with sand bagging at strategic low-lying areas along the north side of the road, however some flooding still occurred.

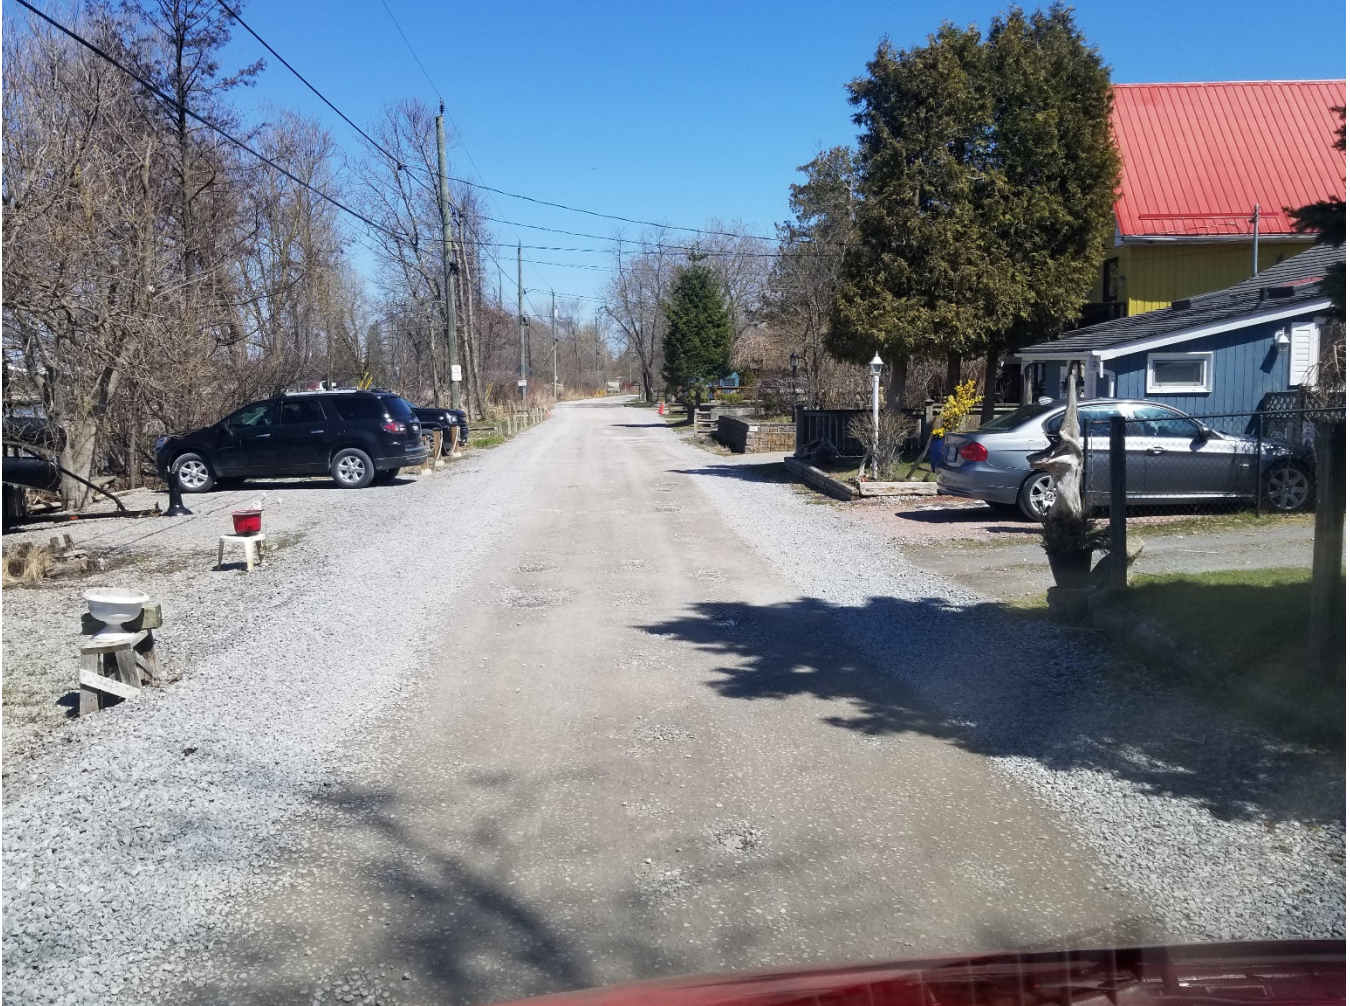
- 1.5 While staff did not undertake a detailed analysis of the option to raise the roads, which would need to be done especially for Cedar Crest Beach Road, it should be noted that gravel has been previously placed along a particularly susceptible area of West Beach Road to address localized flooding. To date, this solution has successfully addressed

the flooding issue. Any further adjustment would restrict the ability of service vehicles to use the road, mainly garbage trucks, due to reduced clearance from overhead utilities. Figure 4 shows the current West Beach Road.

Figure 4: West Beach Road

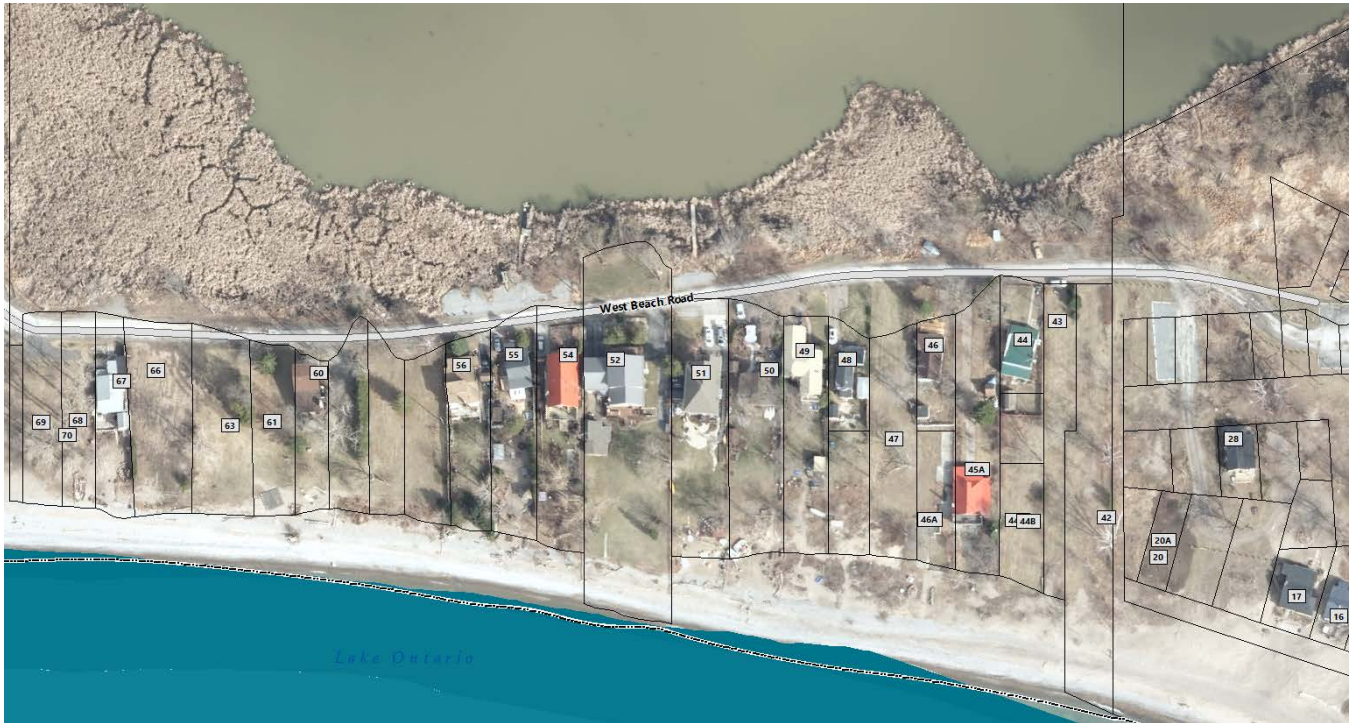
- 1.6 In reviewing the implementation of a flood mitigation berm solution for West Beach Road, there are a number of challenges such as the irregular property boundaries, varied ownership and the close proximity of the marsh water's edge to the road. These challenges would make it very difficult to implement a berm solution without filling in part of the marsh. Based on past experience with natural environmental features such as this marsh, staff would need to undertake a significantly more detailed review and consultation with approval authorities in order to determine if berm mitigation would be a potential option for West Beach Road. For this reason, and the success of road works

to date, it is suggested that staff continue to monitor this section of road, but no further flood mitigation be undertaken. Figure 5 shows an aerial photo of the irregular property limits as well as the proximity of the marsh to West Beach Road.

Figure 5: Property Limits and Marsh Along West Beach Road
